CIVIL AIRCRAFT ACCIDENT

Report on the Accident to
Hermes G-ALDN
in Mauritania (French West Africa)
on 26th May, 1952

Final Report of the Investigation

The Accident to the B.O.A.C. Hermes Aircraft G-ALDN
in Mauritania (French West Africa) on 26th May, 1952

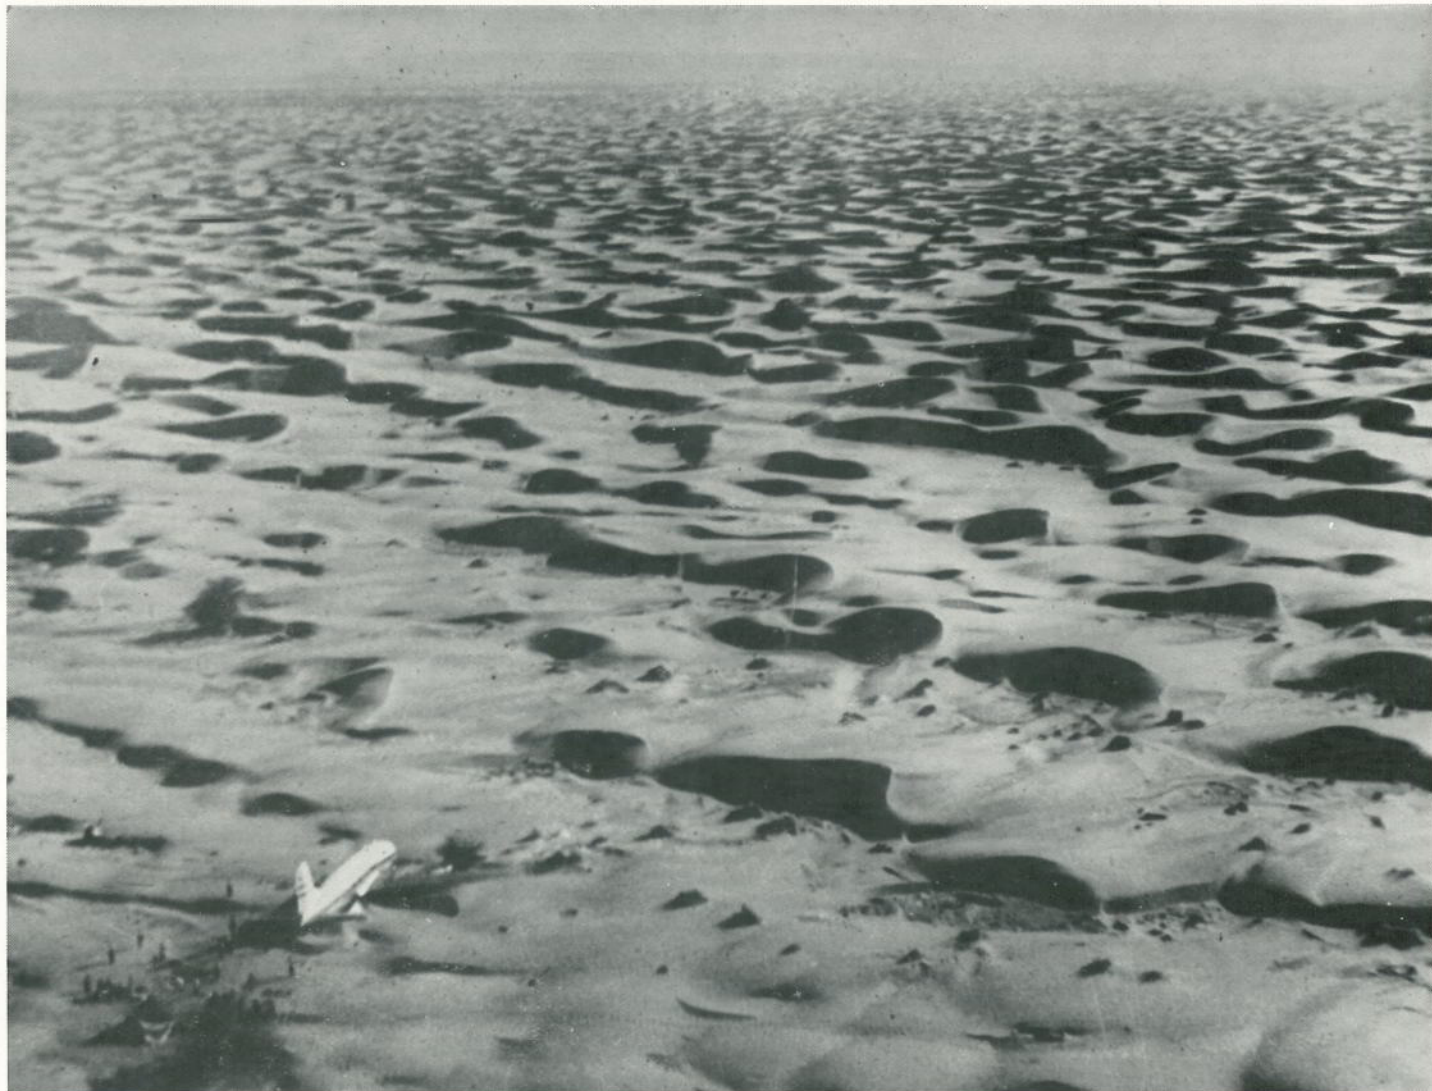
SCENE OF ACCIDENT TO HERMES AIRCRAFT G-ALDN.
DESERT OF MAURITANIA (FRENCH WEST AFRICA).
