CIVIL AIRCRAFT ACCIDENT

Report on the Accident to
Hermes G-ALDN
in Mauritania (French West Africa)
on 26th May, 1952

Final Report of the Investigation

The Accident to the B.O.A.C. Hermes Aircraft G-ALDN
in Mauritania (French West Africa) on 26th May, 1952

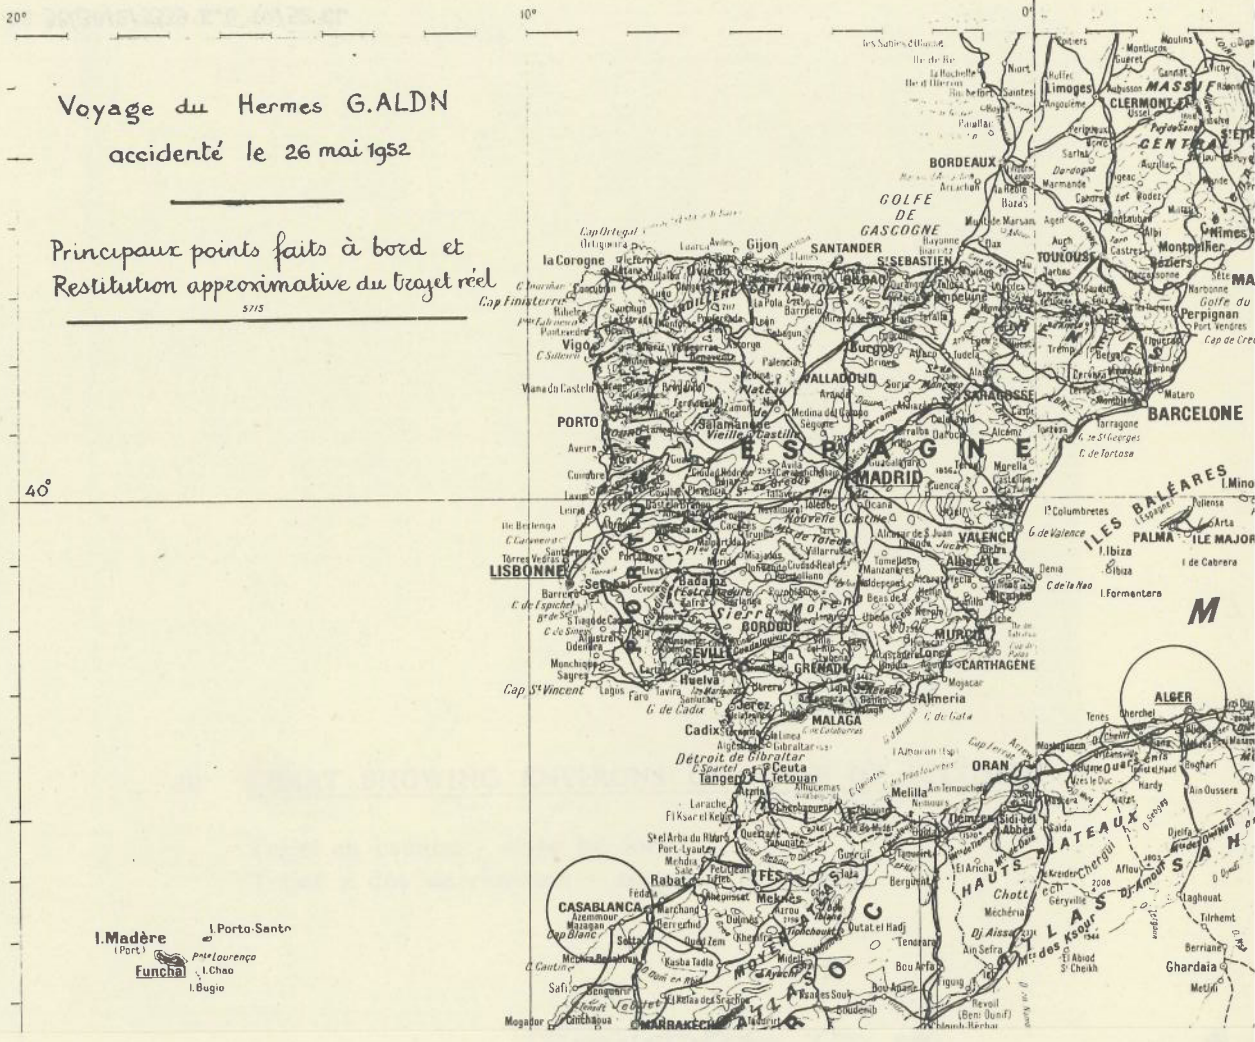
Voyage du Hermes G.ALDN
accidenté le 26 mai 1952

Principaux points faits à bord et
Restitution approximative du trajet réel

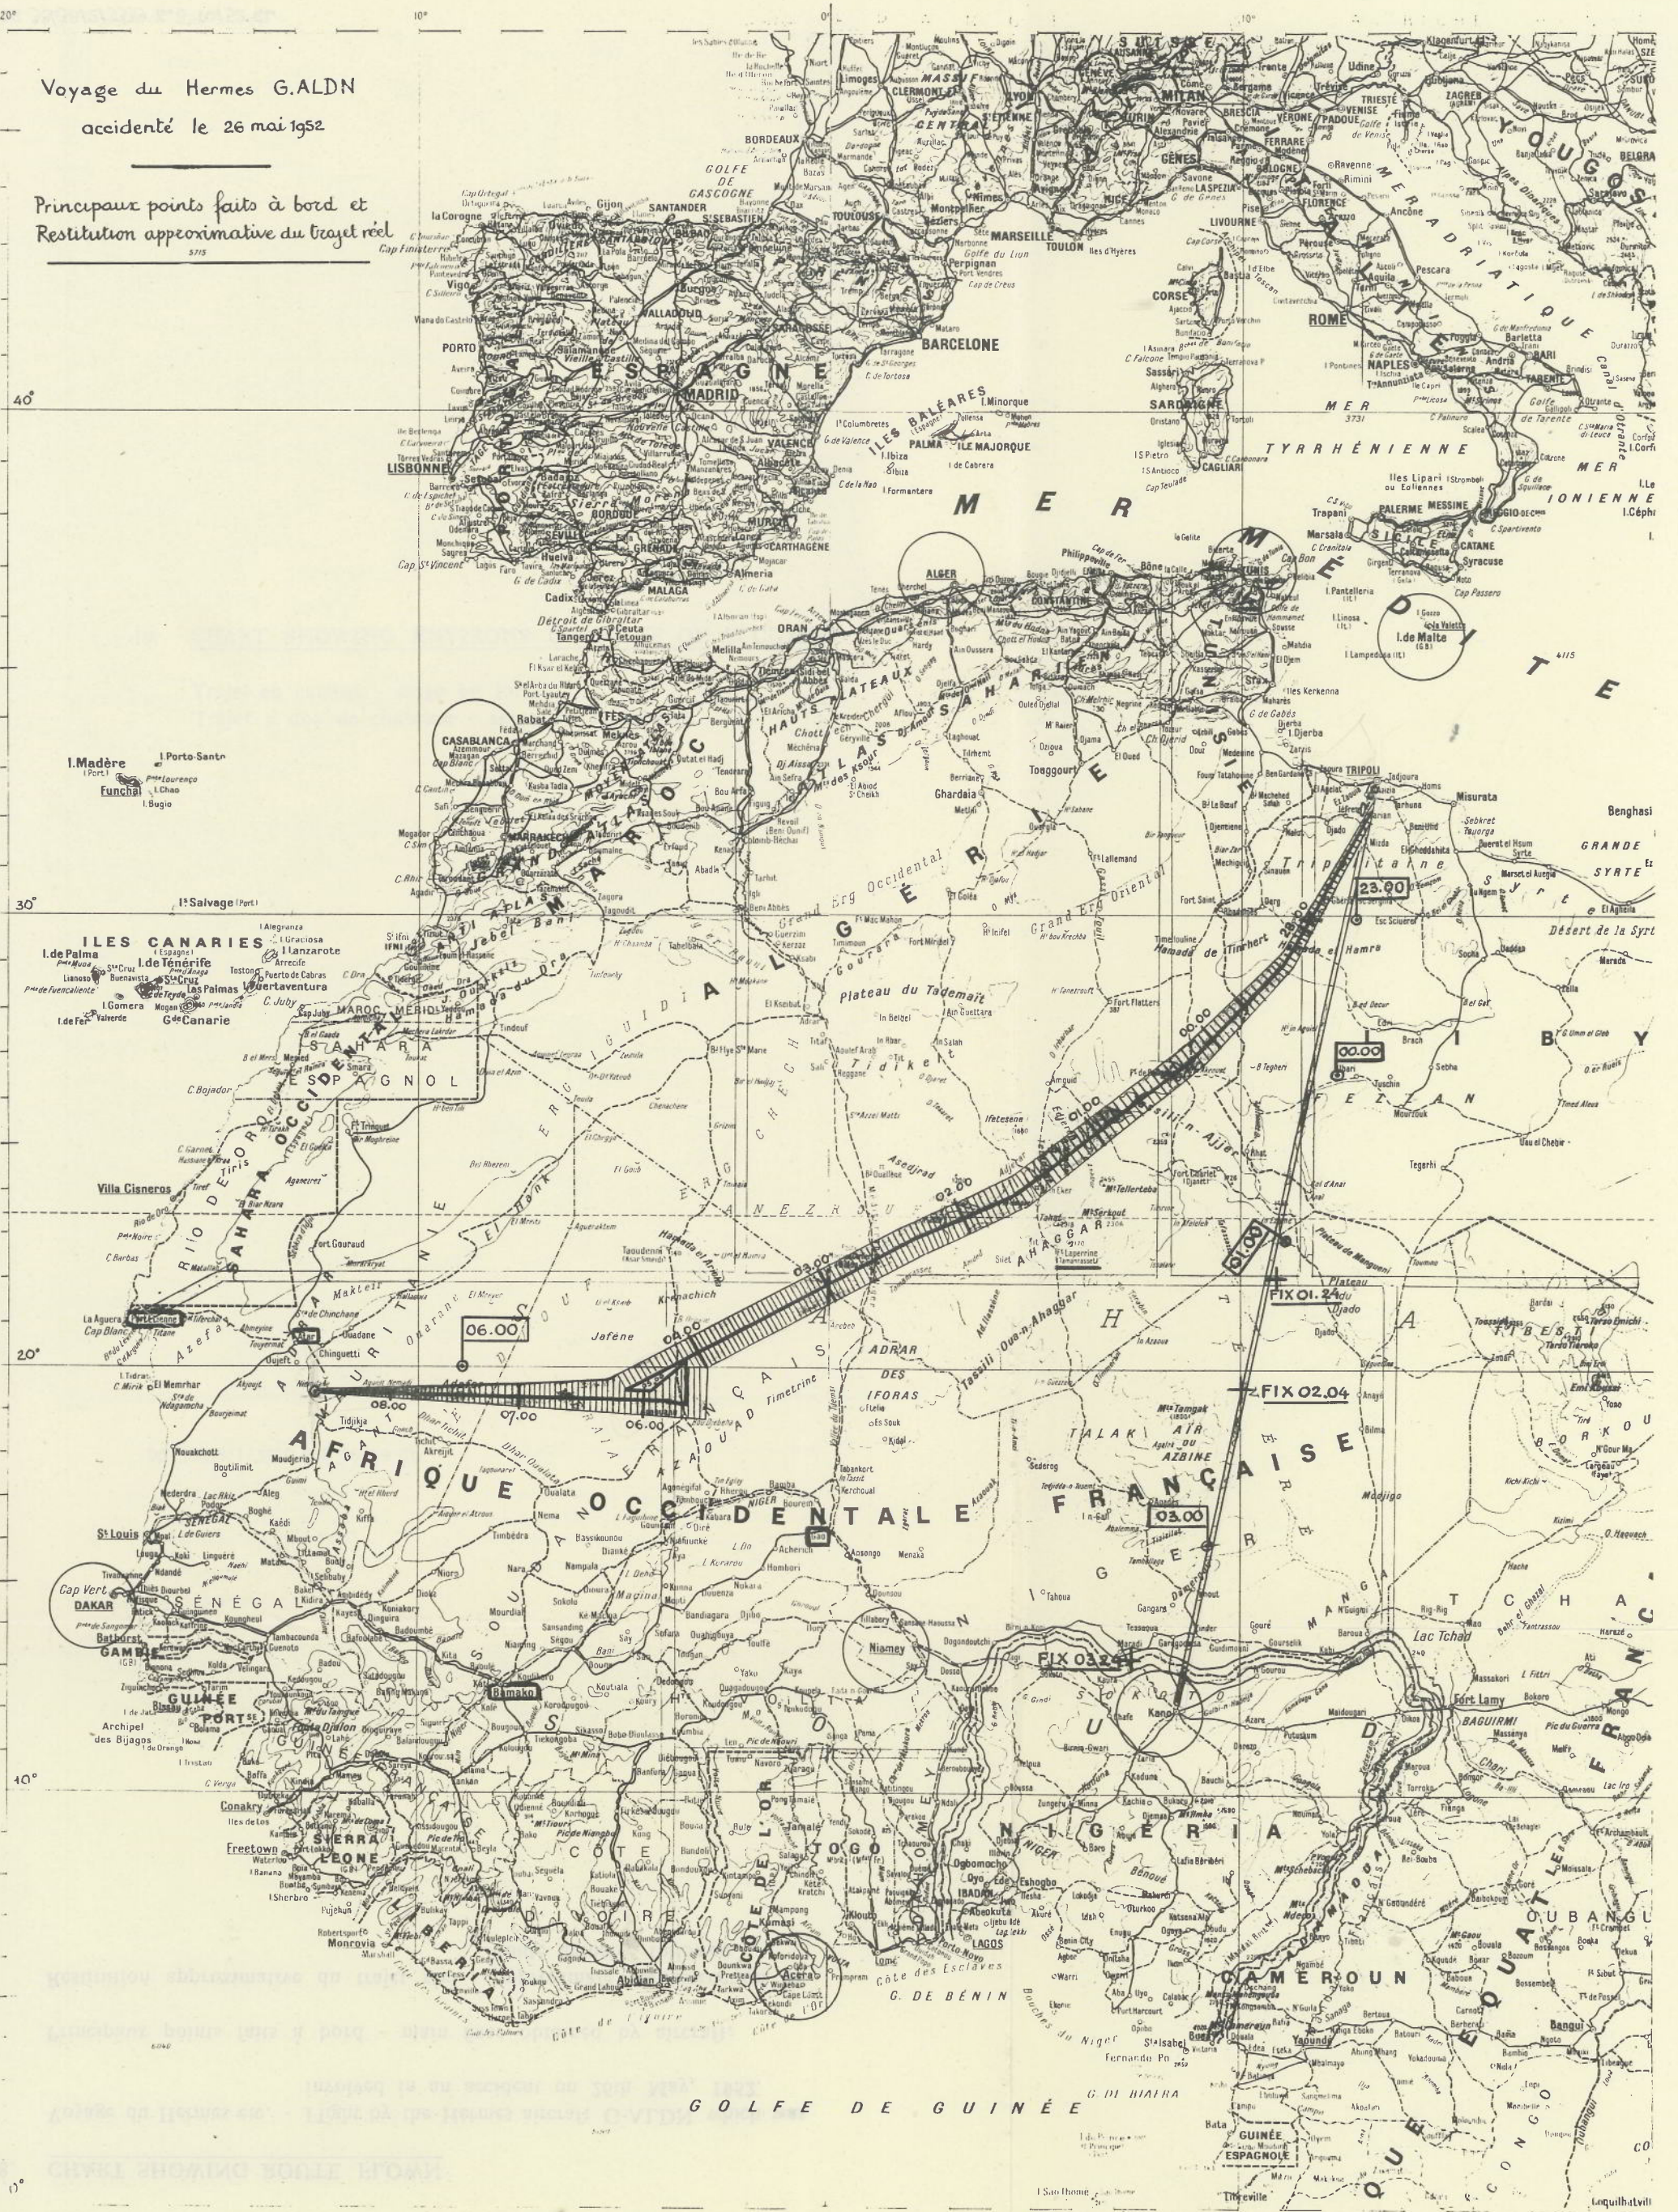
Voyage du *Hermes* G.ALDN
accidenté le 26 mai 1952

Principaux points faits à bord et
Restitution approximative du trajet réel
